AFML-TR-79-4207-VOL-2
VOLUME II

CHARACTERIZATION OF TYPICAL PRODUCTION HOLE QUALITY AND INSPECTION TECHNIQUES.

VOLUME II. APPENDIXES B, C, D.

MARTIN MARIETTA AEROSPACE
DENVER DIVISION
DENVER, COLORADO 80201

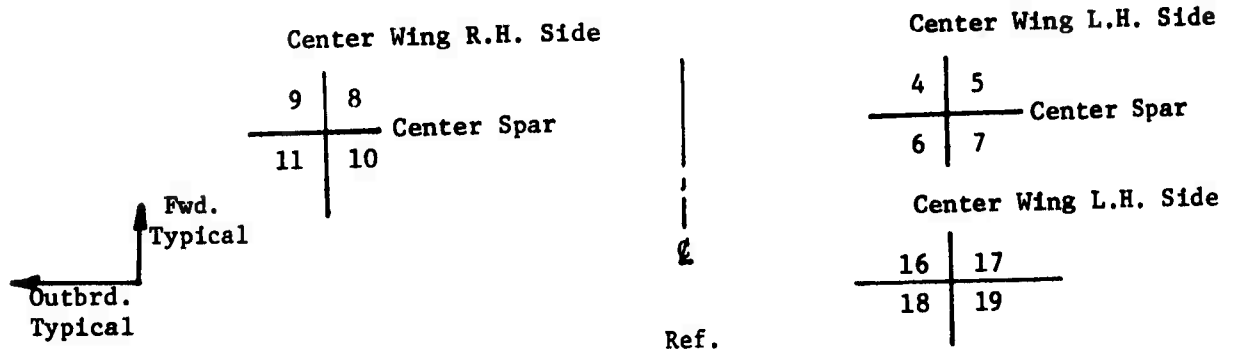
View looking up at the Center Wing Lower Surface

The assembly of the center wing structure was controlled by a very good individually serialized manufacturing Log Plan. Instructions were clear and concise for work tasks and inspection; including, mandatory AFQA inspection points.

Heavy custom tooling coordinated to the main landing gear trunion fitting hole pattern and the fixture provides a stable, accurate and reliable means to mount the Quackenbush power unit and ensure proper location/interchangeability of the pylon mounting holes. A siphon fed air-mist coolant system is employed during the drilling/reaming operations.
